**Bull Trout Habitat Restoration:  
Feather River Culvert Passage  
Completion Report**

**Threatened and Endangered Species Report  
Project E-17-1  
Section 6, Endangered Species Act**

# **COMPLETION REPORT**

**GRANT TITLE:** Bull Trout Habitat Restoration: Feather River culvert passage

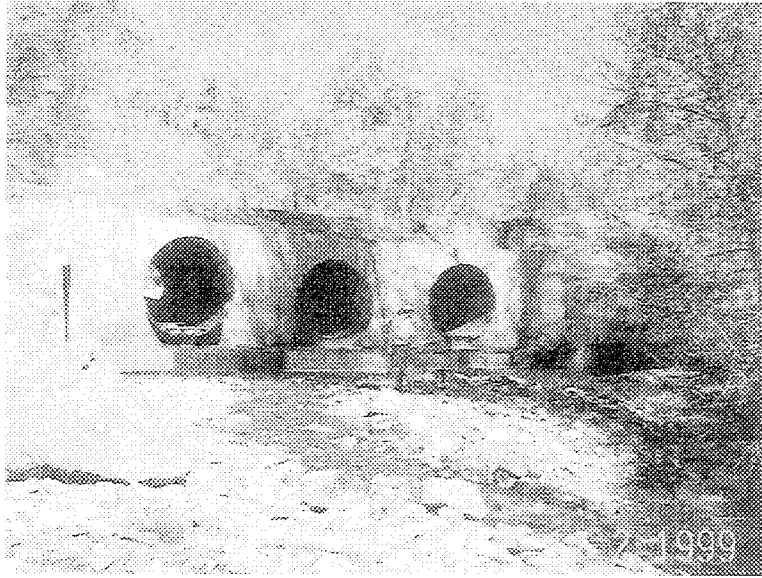
During 1999, radio tracking of adfluvial bull trout from Anderson Ranch Reservoir showed that the Featherville Culvert was not a complete block for upriver migrating fish (Partridge et al. 2000). Three radio tagged bull trout ranging from 435 to 505 mm at time of capture were found above the culvert during the summer. Passage likely occurred through the eastern culvert which contained two improperly constructed joints in culvert material which reduced water velocities at the bottom of the culvert. Although some passage is occurring, the project was continued since an encroaching headcut below the culvert would increase the jump for fish into the culvert within a year or two.

Photo 1. Featherville culverts prior to rock structure construction in November 1999.

During November 1999, three rock drop structures were constructed in the channel below the culvert to stabilize the channel headcut and at high flows, flood the concrete apron below the culvert outfall thereby providing better fish access to the culverts (Photos 1 and 2). Rock for the structures was donated by the Glenns Ferry Highway District. Approximately 115 cu meters of rock was transported 20 km to Featherville from the upper end of Anderson Ranch Reservoir. Rocks and filter fabric were also placed along the west side of the stream between the culverts and the first structure to reduce erosion along the road bed. During construction, willow cuttings were placed under the drop structure rocks at the stream bank and along the rip rap. Soil was placed over the rip rap above the high water line and seeded with a grass and forb mix. Drop structure and rip rap construction was performed by the Idaho Fish and Game Engineering crew. Also in November, 1999, regional personnel placed a fishway (Clancy and Reichmuth 1990) in the western culvert to reduce water velocities (Photo 3). In the fall of 2000, rebar rock supports were added to the fishway cross pieces to help hold both the fishway and rocks in place (Photo 4).

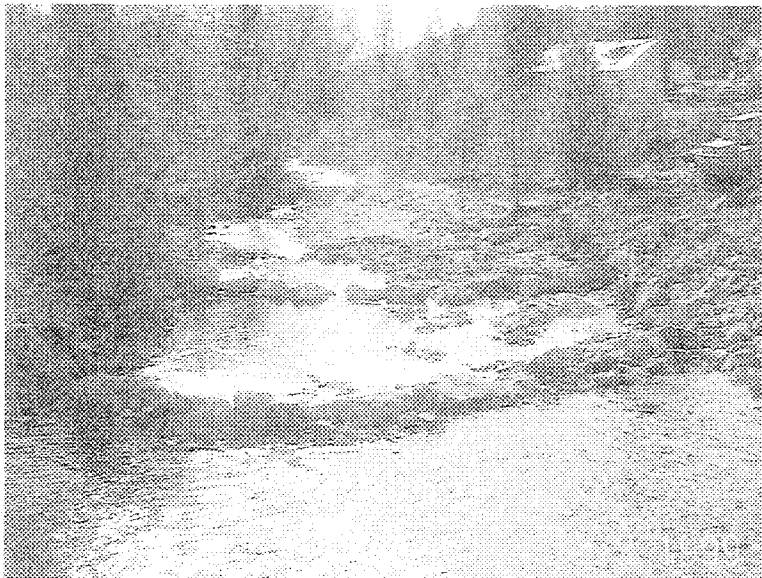
Photo 2. Completed rock structures below Featherville culverts in November 1999.

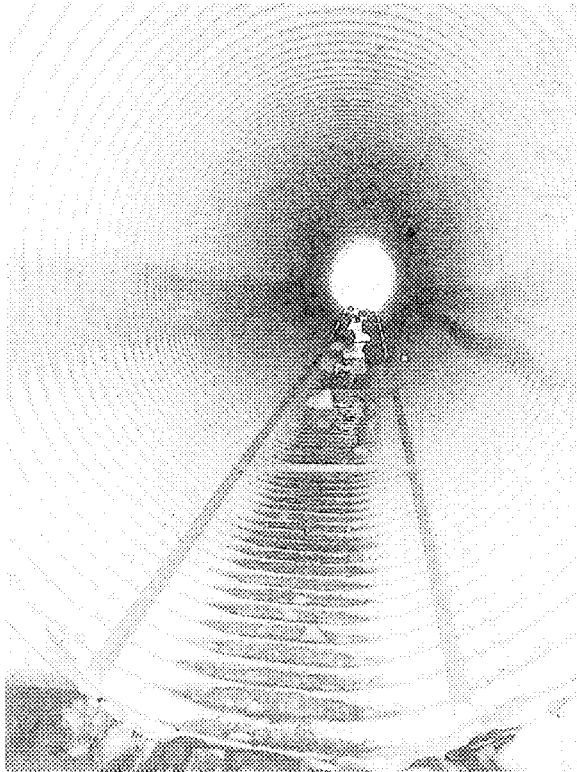
Photo 3. Fishway in west Featherville culvert.

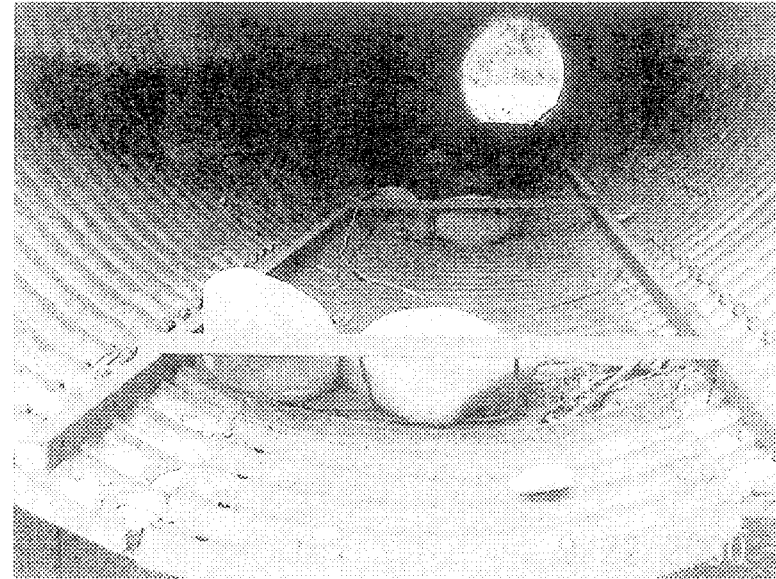
Photo 4. Fishway structure inside the western culvert with added center rock supports.

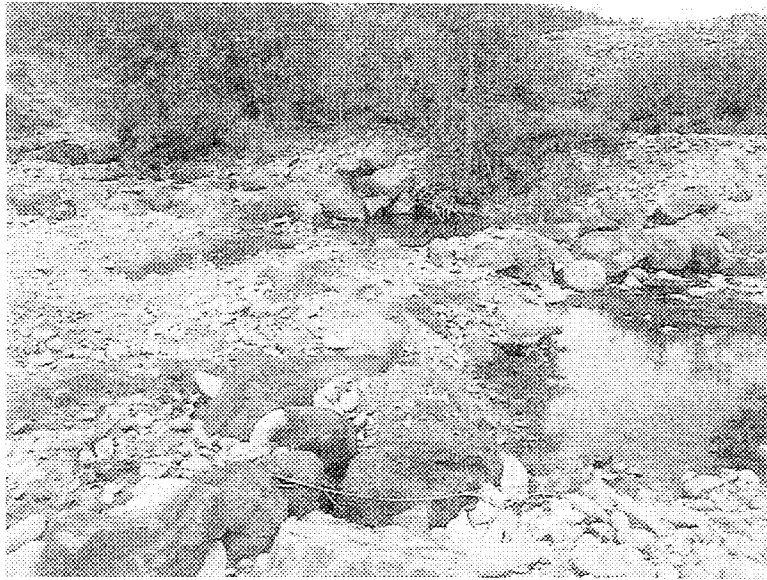
Photo 5. Reconstructed lowermost rock structure at the Featherville Culvert project.

During 2000, spring runoff dislodged a couple of boulders in the furthestmost downstream structure. Due to low precipitation during summer months, flows in the Feather River at the culverts ceased allowing repairs to the structure to be made without working in flowing water. These boulders were replaced in the structure and an additional 40 cu. meters of boulders were added to the lower two structures to increase their stability (Photo 5). Additional photos show the structures under springtime flow conditions along with grasses and willows beginning to grow along the disturbed west bank (Photo 6-8).

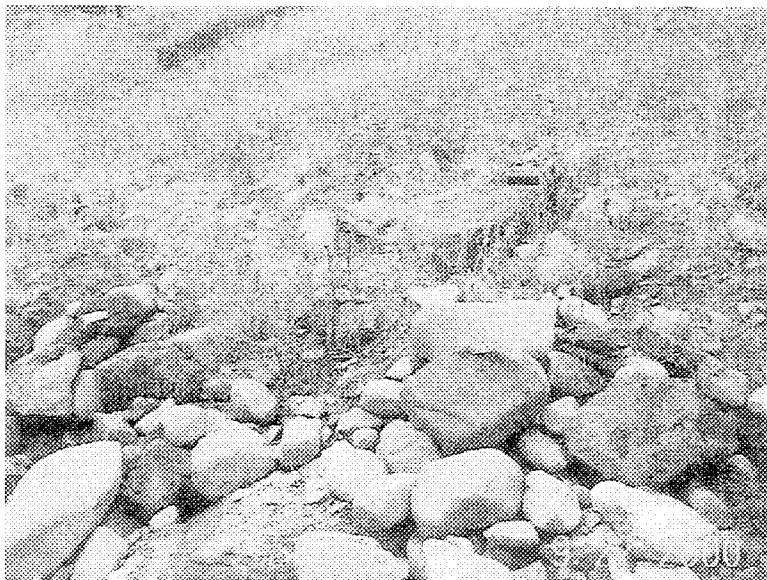
Photo 6. Reseeded west bank with some willow sprouting at end of rock structure.

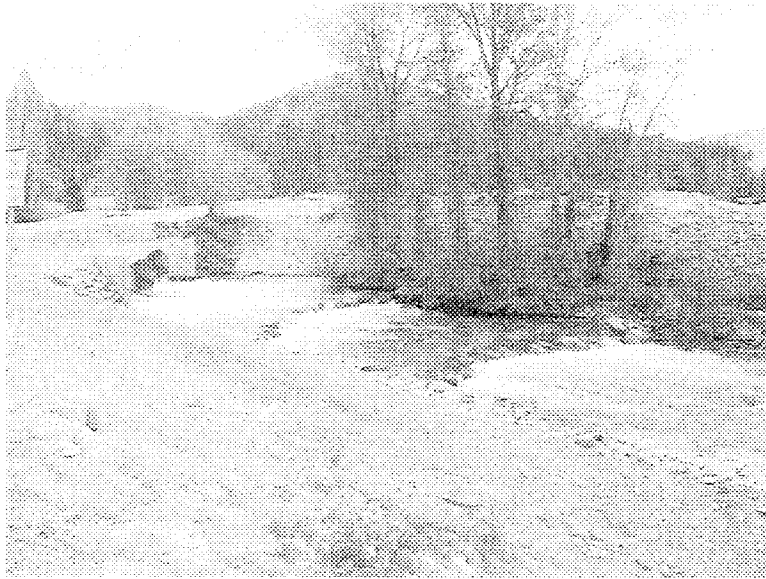
Photo 7. Reseeded bank vegetation starting to grow along the west side of the Featherville Culvert project, May 4, 2000.

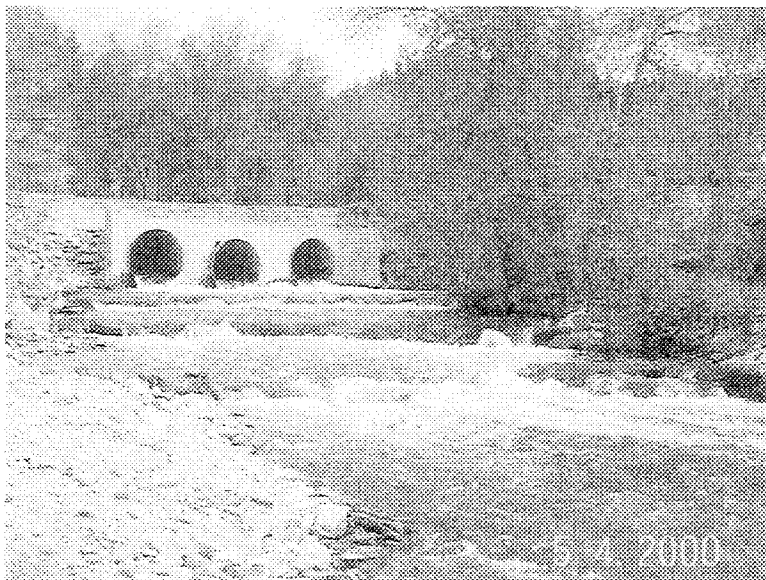
Photo 8. Upstream view from below the Featherville Culverts during moderately low 2000 spring runoff period.
